NASA TN D-563

# INVESTIGATION OF S-IV ALL SYSTEMS VEHICLE EXPLOSION

*George C. Marshall Space Flight Center  
Huntsville, Ala.*

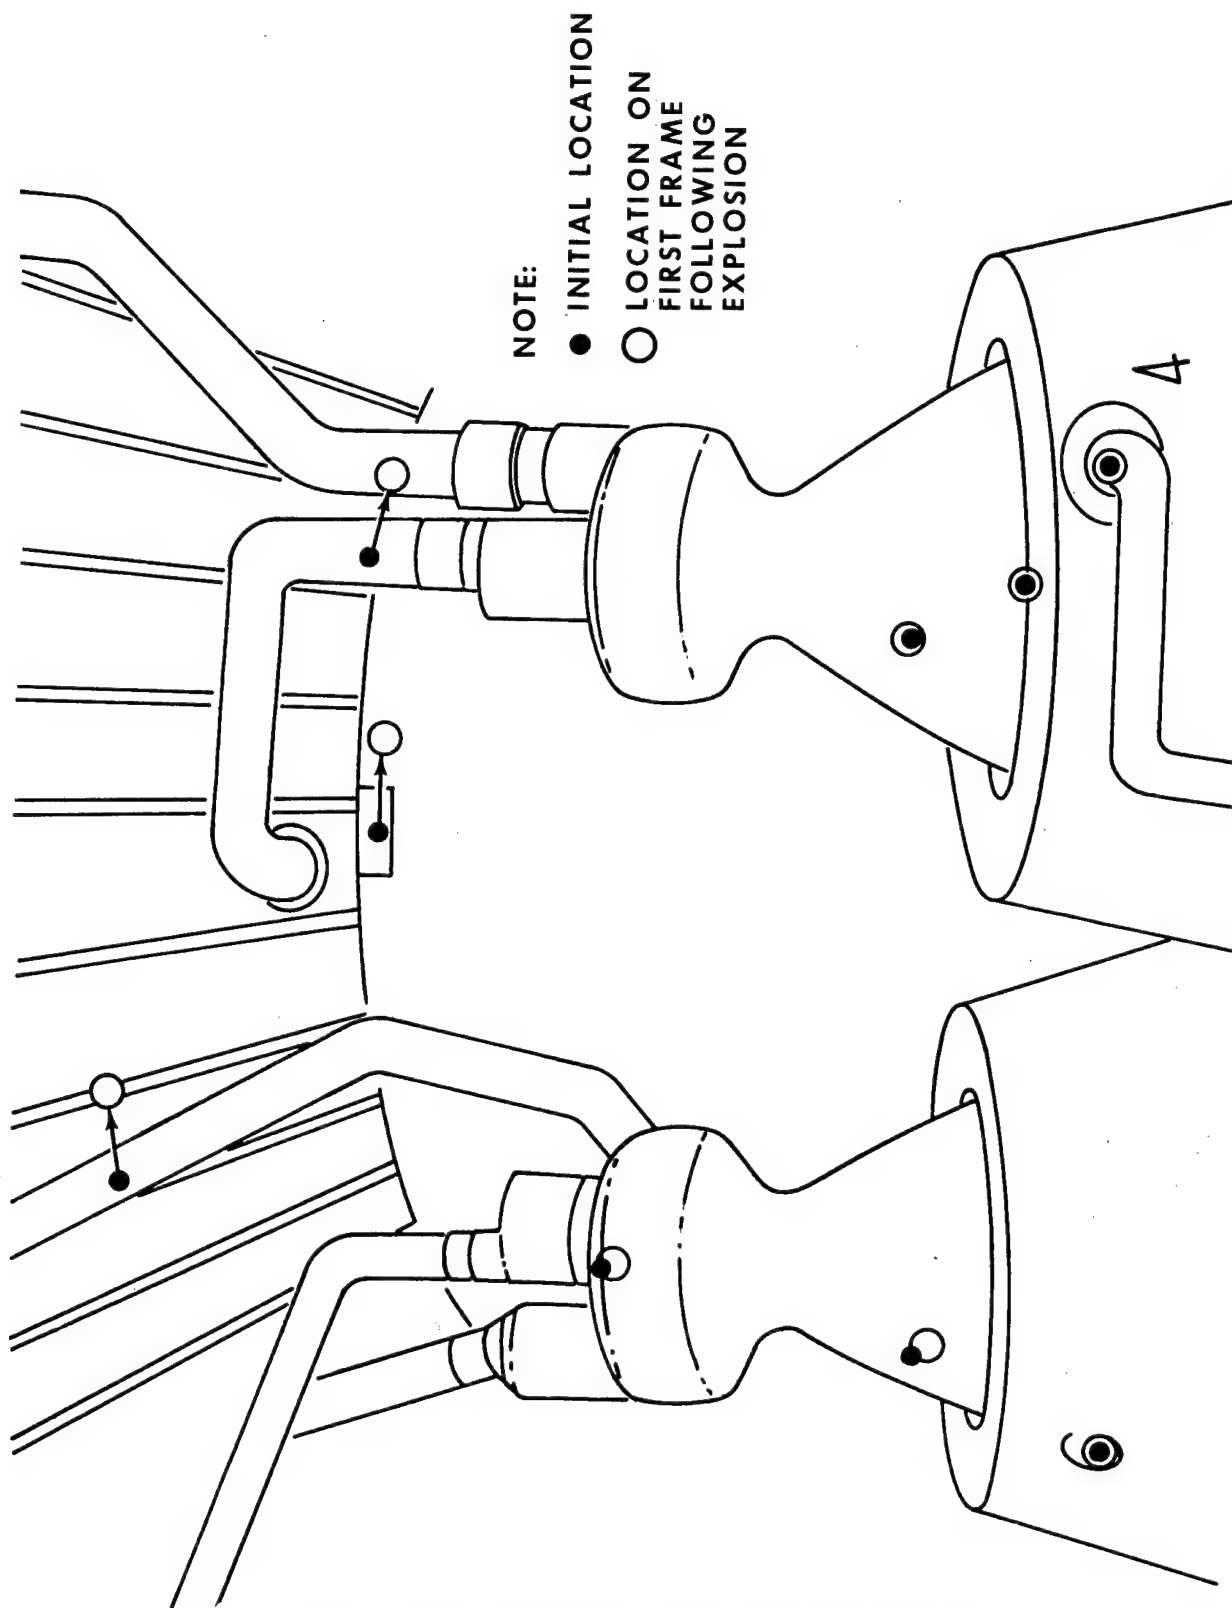
FIGURE 1. MOVEMENT OF VEHICLE AFTER EXPLOSION

Inspection of photographs prepared by enlarging individual frames from one of the engine area cameras indicated that the initial motion of the vehicle caused by the explosion had a definite westerly vector. This was determined by locating readily definable parts of the vehicle with reference to the test stand structure from photographs taken immediately before and after the start of the explosion. The results are shown in FIG 1. The movement from left to right shown in this figure represents movement in a north-west direction. Since this analysis indicates that the initial movement of the upper part of the vehicle was toward rather than away from the apparent center of the explosion, it appears that the principal explosion may have been preceded by a smaller one located near the periphery of the vehicle.

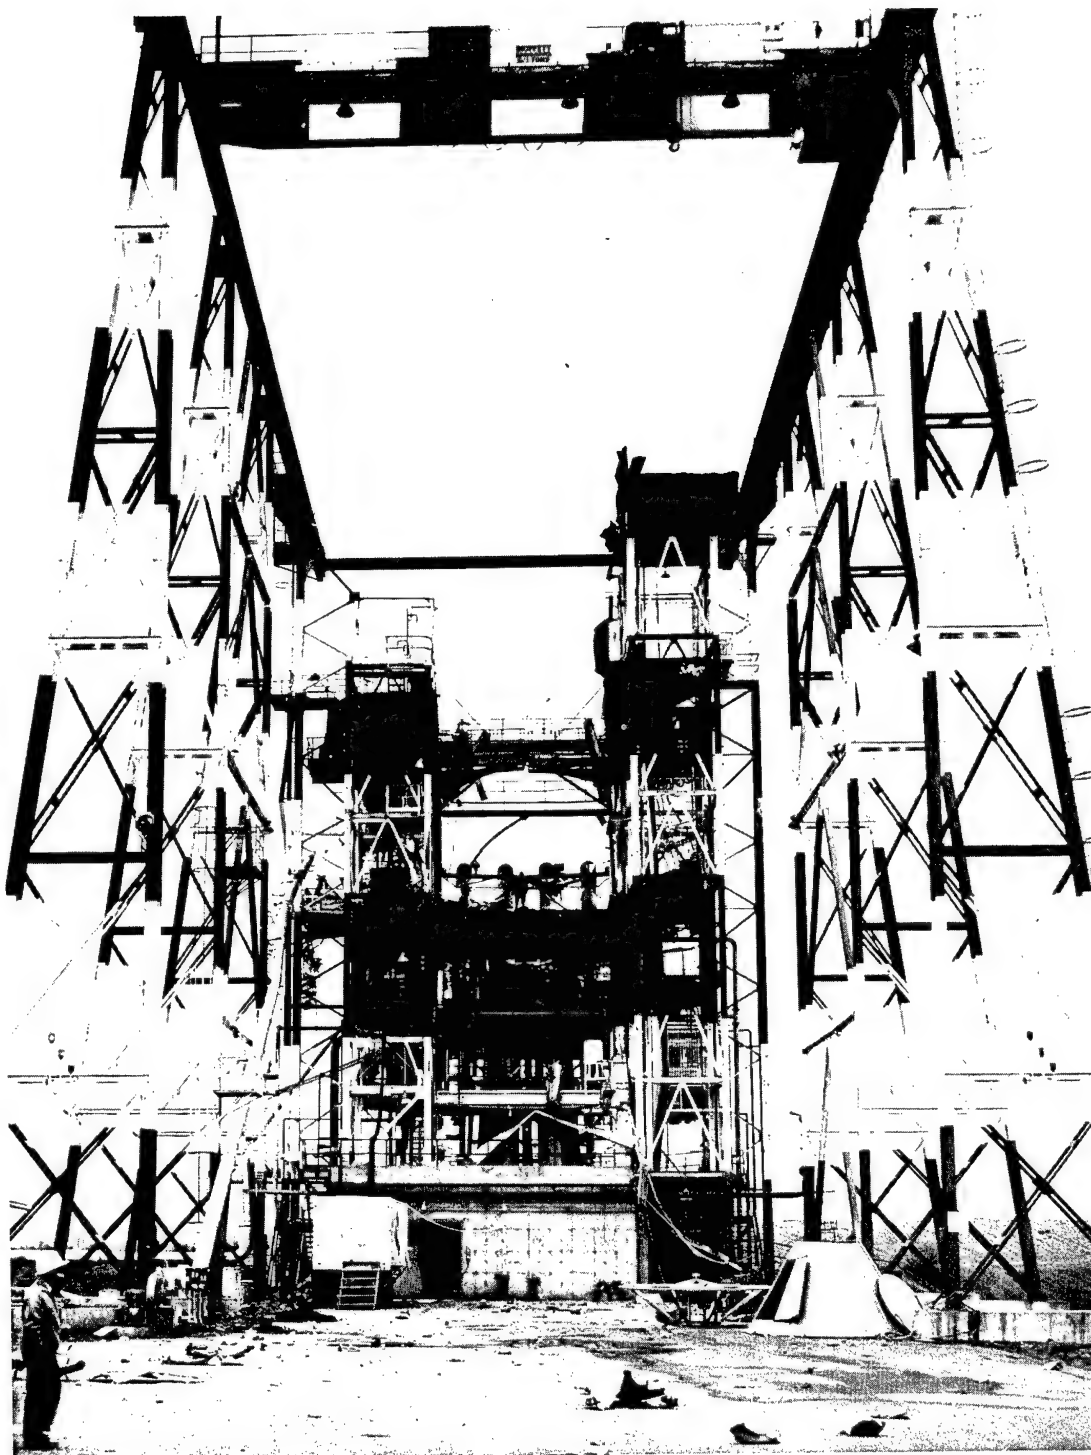
FIGURE 2. VIEW OF TEST STAND AFTER EXPLOSION

Figure 2 shows the test stand and vicinity after the explosion. Inspection of this figure indicates that the overhead crane and supporting structures were virtually undamaged and that the effects of the explosion were largely confined to the test stand proper.

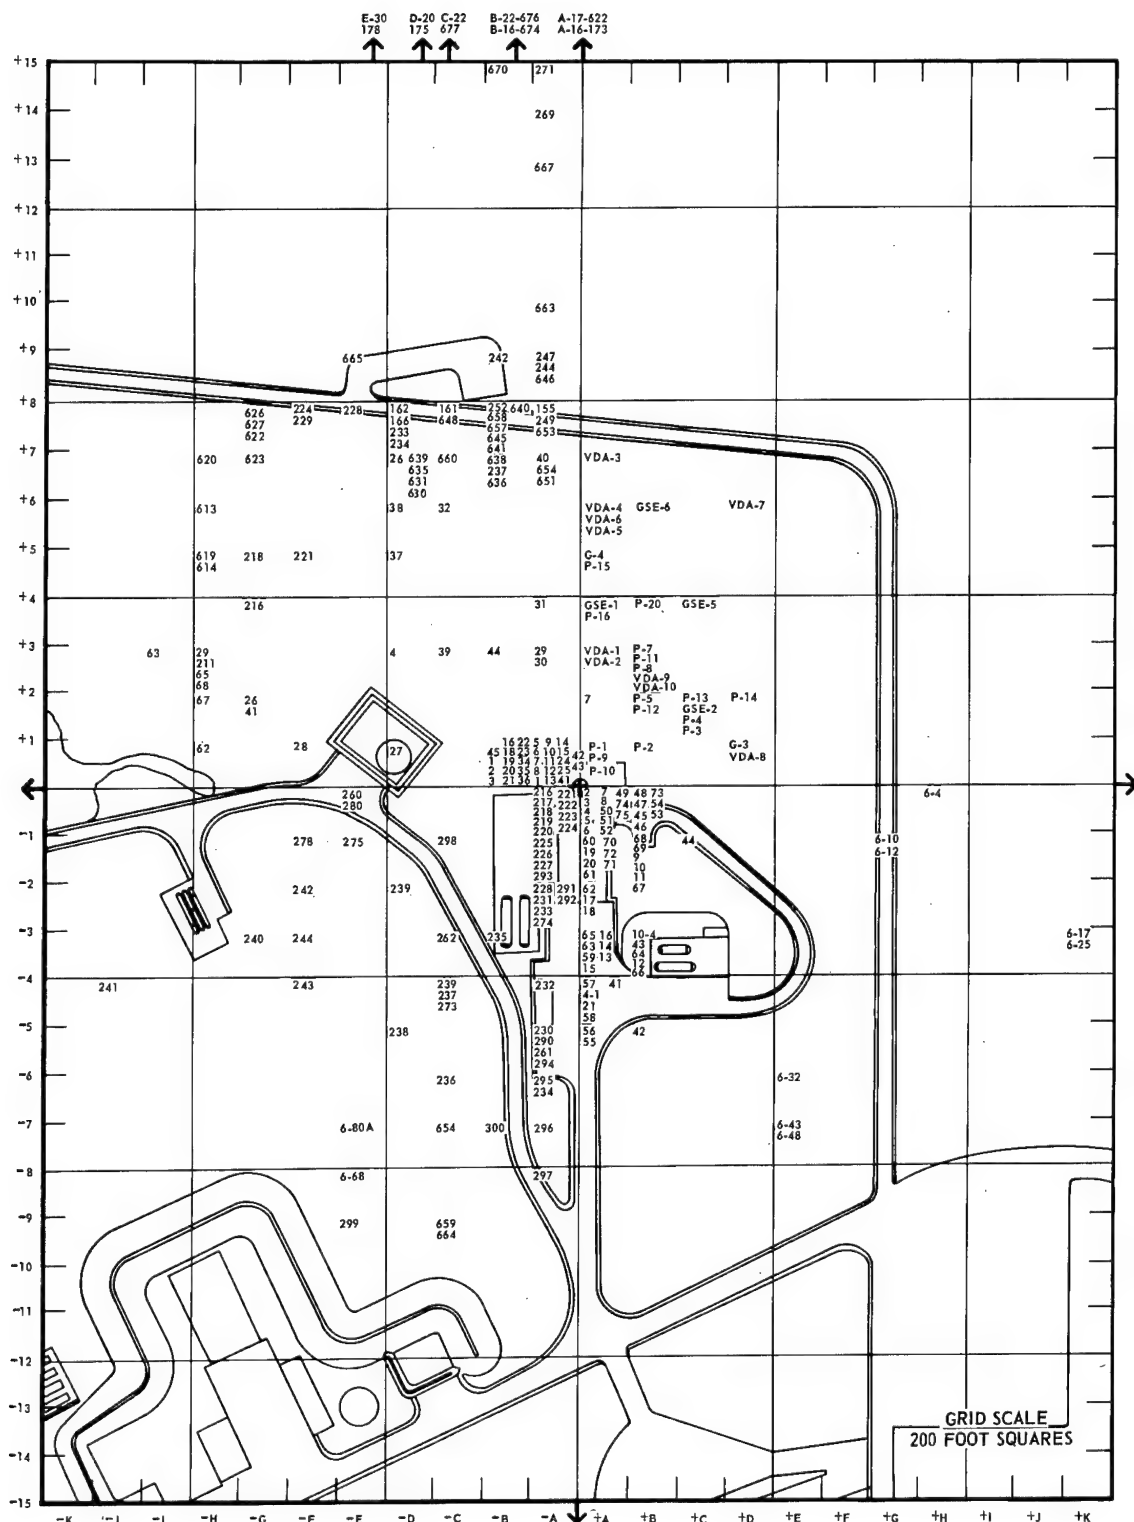
FIGURE 3. FRAGMENT DISPERSION PATTERN

Figure 3 is a map showing the location of debris which was dispersed as shrapnel. Table II gives the identification of the fragments shown on FIG 3. Table III is a tabulation of the approximate sizes, weights, and locations (in distance from the center of the explosion) of fragments selected for possible detailed investigation.

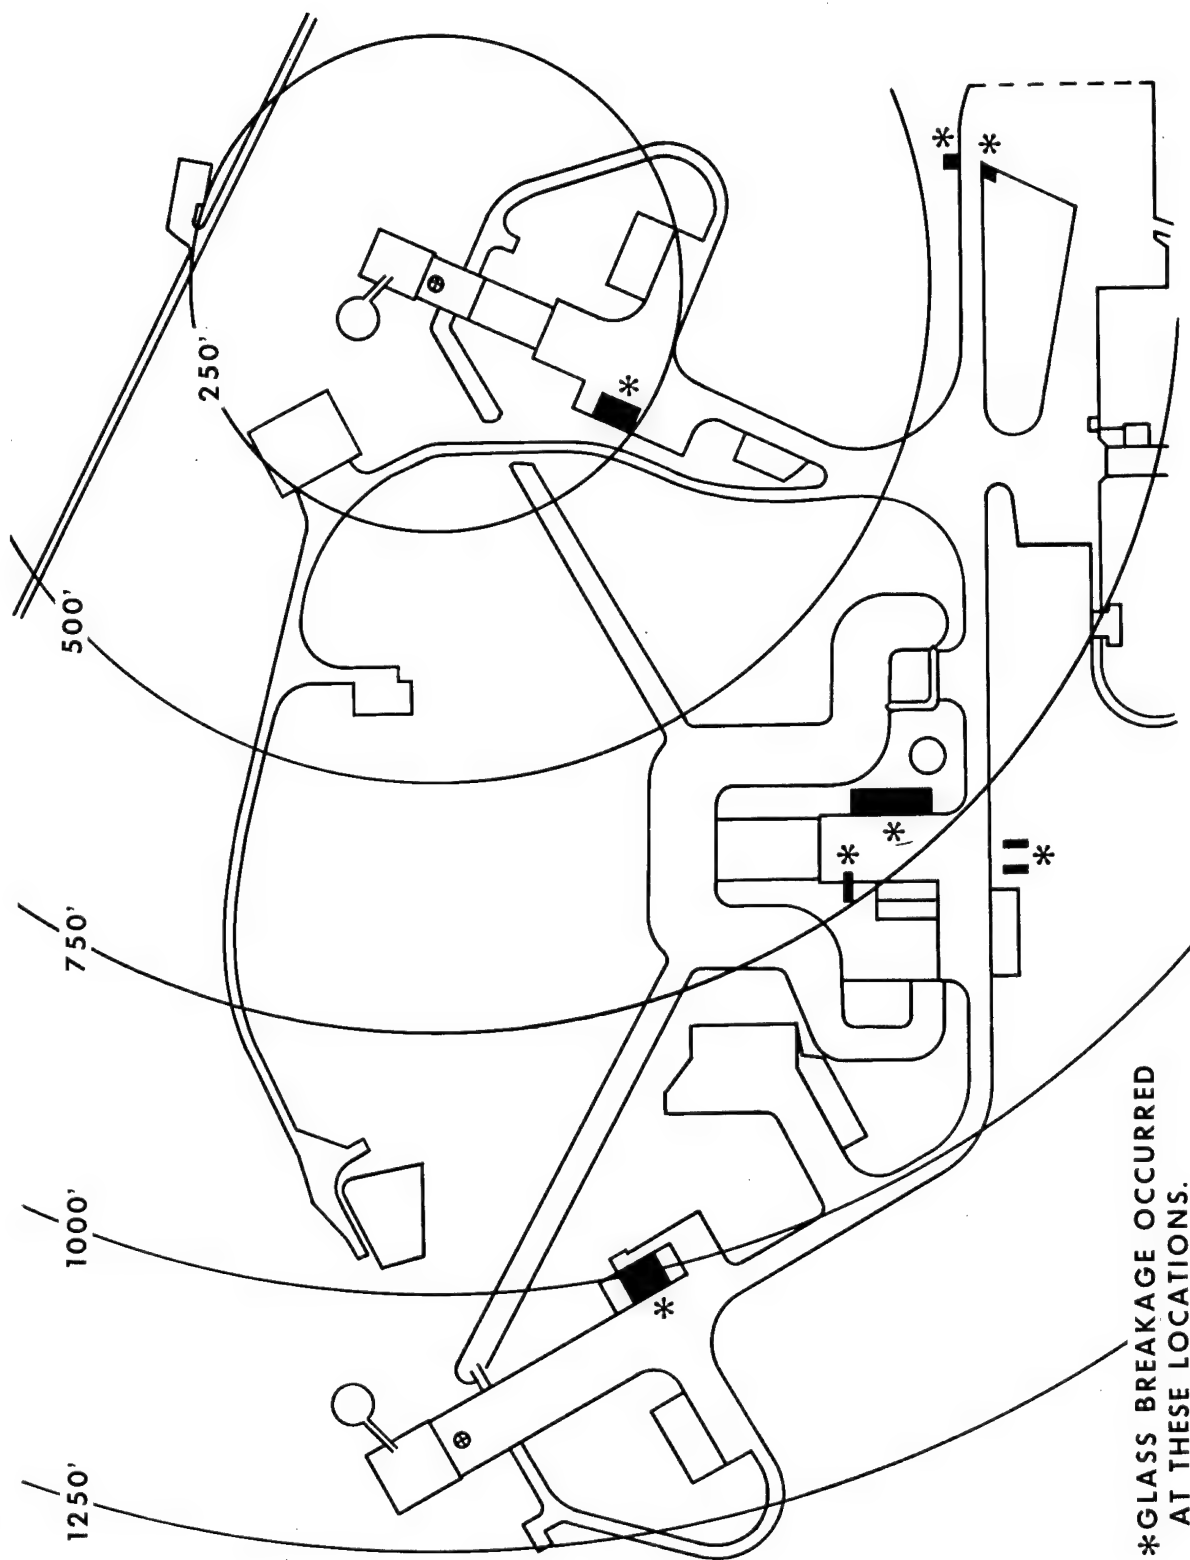
FIGURE 4. GLASS BREAKAGE PATTERN

Glass breakage occurred at distances up to approximately 1,100 feet from the center of the explosion, as shown in FIG 4. Most significant to this study were windows broken in guard shacks, house trailers, and Butler buildings.

Subject to the foregoing reservations, it is possible to get an estimate of the yield. Inspection of all available data indicated that the analysis probably should be restricted to evidence from only two sites of glass breakage.

a. All the window panes facing the center of the blast were broken in the guard house, 540 feet from the explosion.

b. Of the 18 panes in the pump house that were roughly in line-of-sight, six were broken, 700 feet from the explosion.

These data indicate that the average distance for glass breakage, i.e., the distance at which about half the glass would have been broken, was between 540 and 700 feet. An appropriate formula to use is as follows:

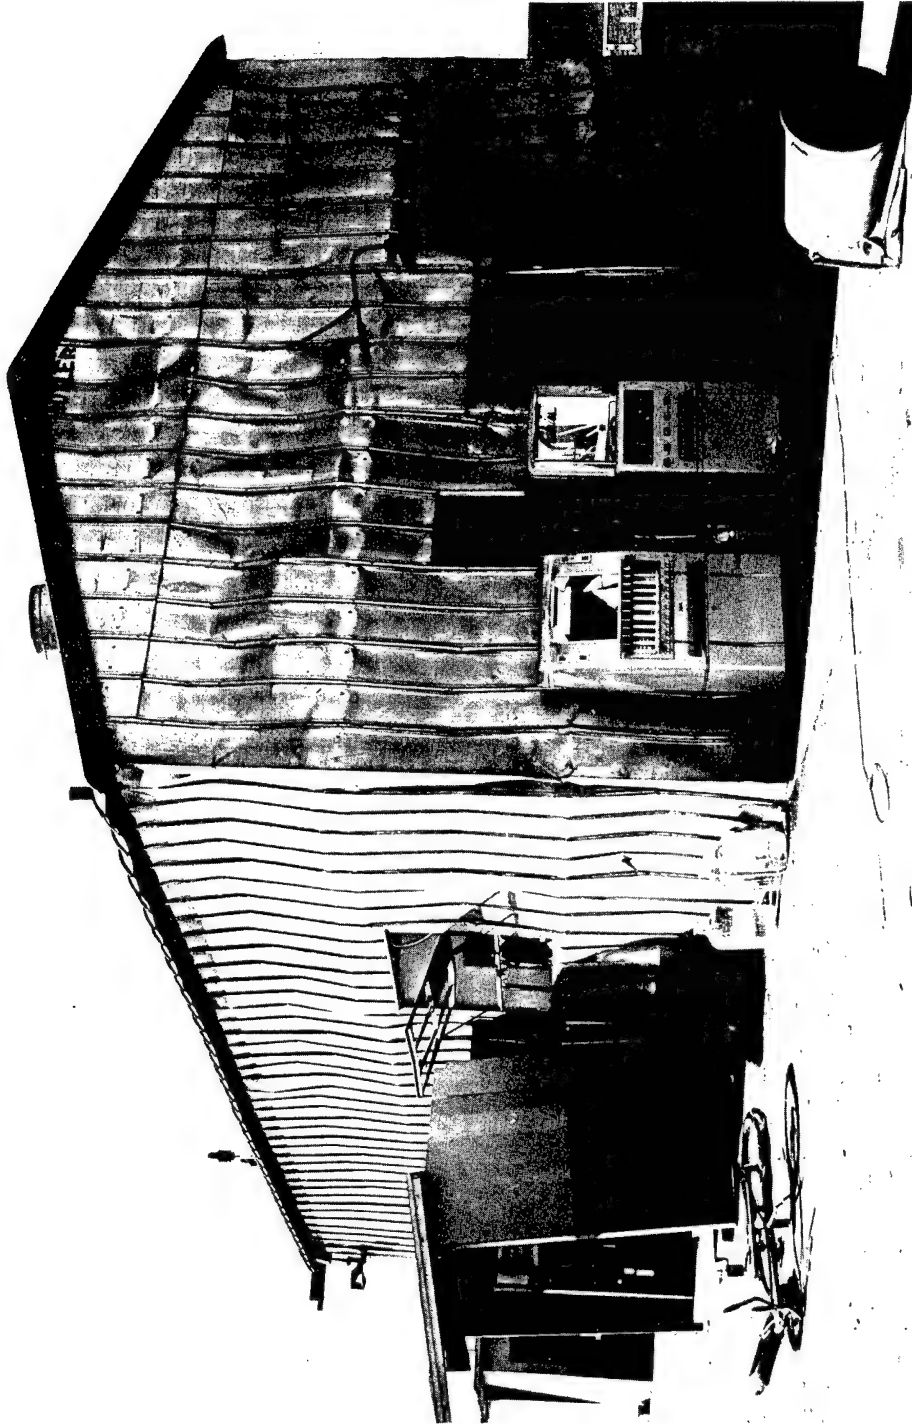
FIGURE 5. DAMAGE TO BUTLER BUILDING, TS-1

The Butler Building designated TS-1 suffered what we considered relatively light damage (FIG 5). One end of this building was positioned facing the blast, with the nearest surface at a distance of 210 feet from a point on the ground directly below the assumed center of the explosion. Damage to the test stand is described by individual levels.

This building was a lightweight sheet metal structure measuring 20' x 48' x 15'. It was positioned end-on to the direction of blast with the nearest end surface at a distance of 210 feet from a point on the ground directly below the assumed center of detonation.

Damage sustained by the Butler building was considered to be relatively light. The most extensive damage occurred on the end facing the blast, which would have been within the Mach stem. A general description of the damage would include a wrinkling to a slight crushing of the corrugated steel panels of from four to six inches in both the side walls and roof. Several windows were broken on the sides receiving the more direct blast, but only one was broken on either of the other two sides. Several structural members in the roof were slightly buckled or deflected a maximum of two inches while several others were loosened at the joints.

It has been assumed that a reflected overpressure of nearly five psi would be necessary at the near end of the building to produce damage of this extent from a relatively short (something less than 50 milliseconds) duration blast wave. The side-on overpressure at the near end of the building would then be approximately 2.5 psi and would require a high explosive weight of approximately 760 pounds.

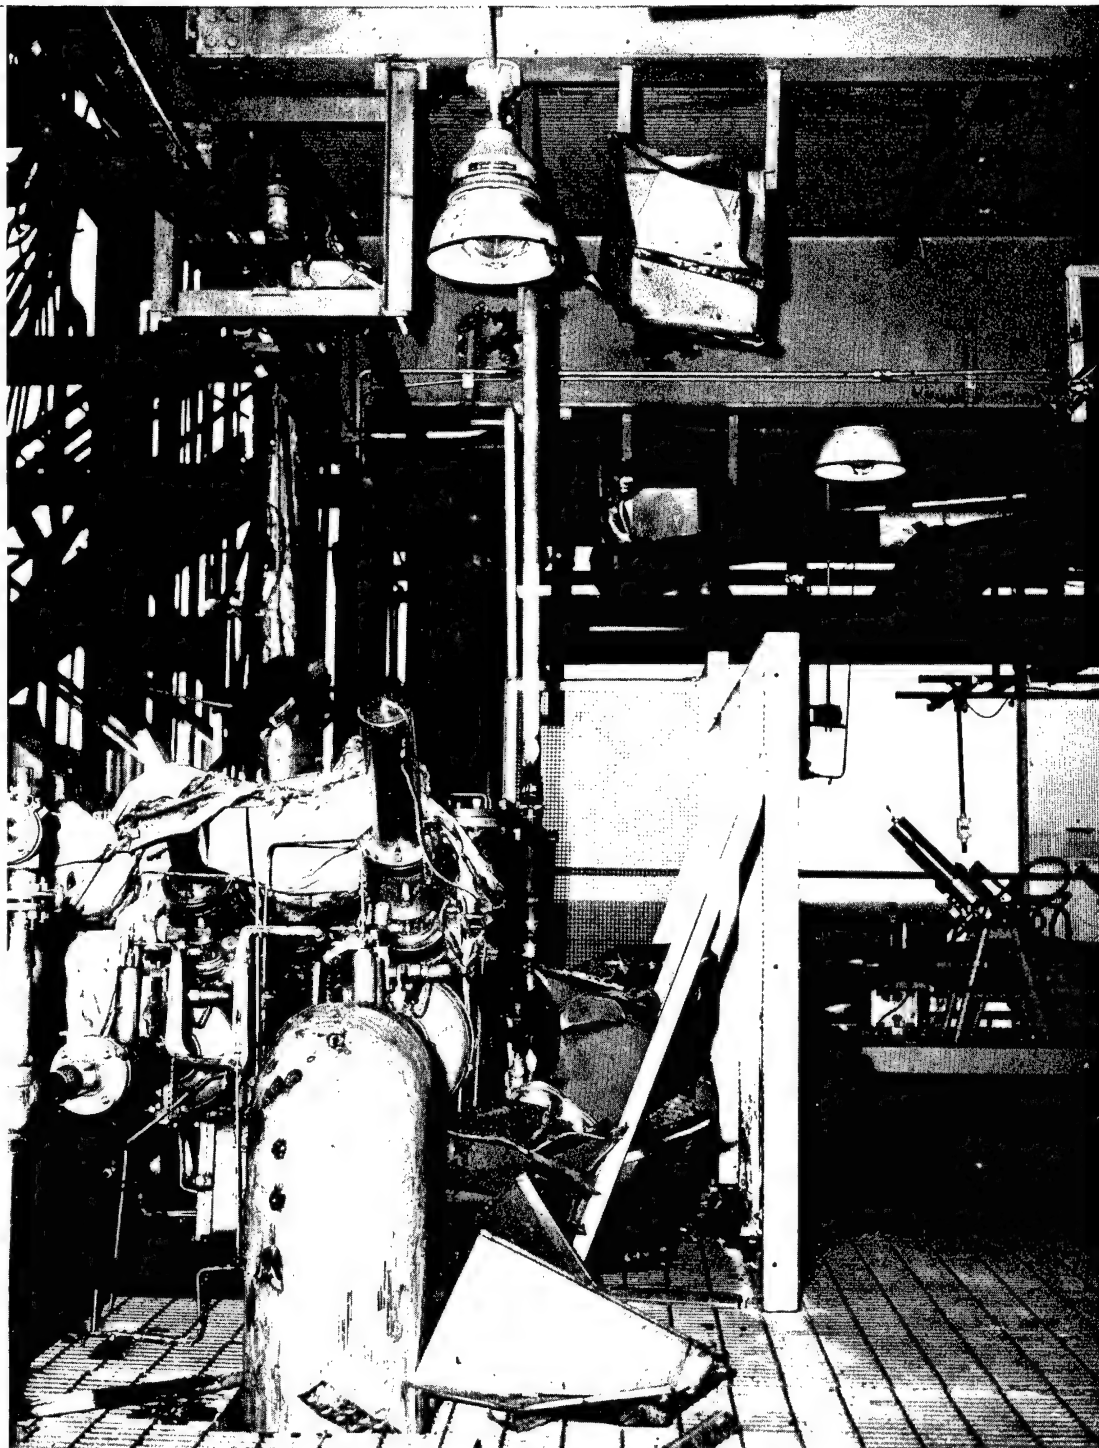
FIGURE 6. LIQUID HYDROGEN AND OXYGEN SLEDS (3rd LEVEL)

The liquid oxygen sled did not appear damaged. On the liquid hydrogen sled, flammable foam insulation was burned and valve handles were singed, but damage appeared inconsequential (FIG 6).

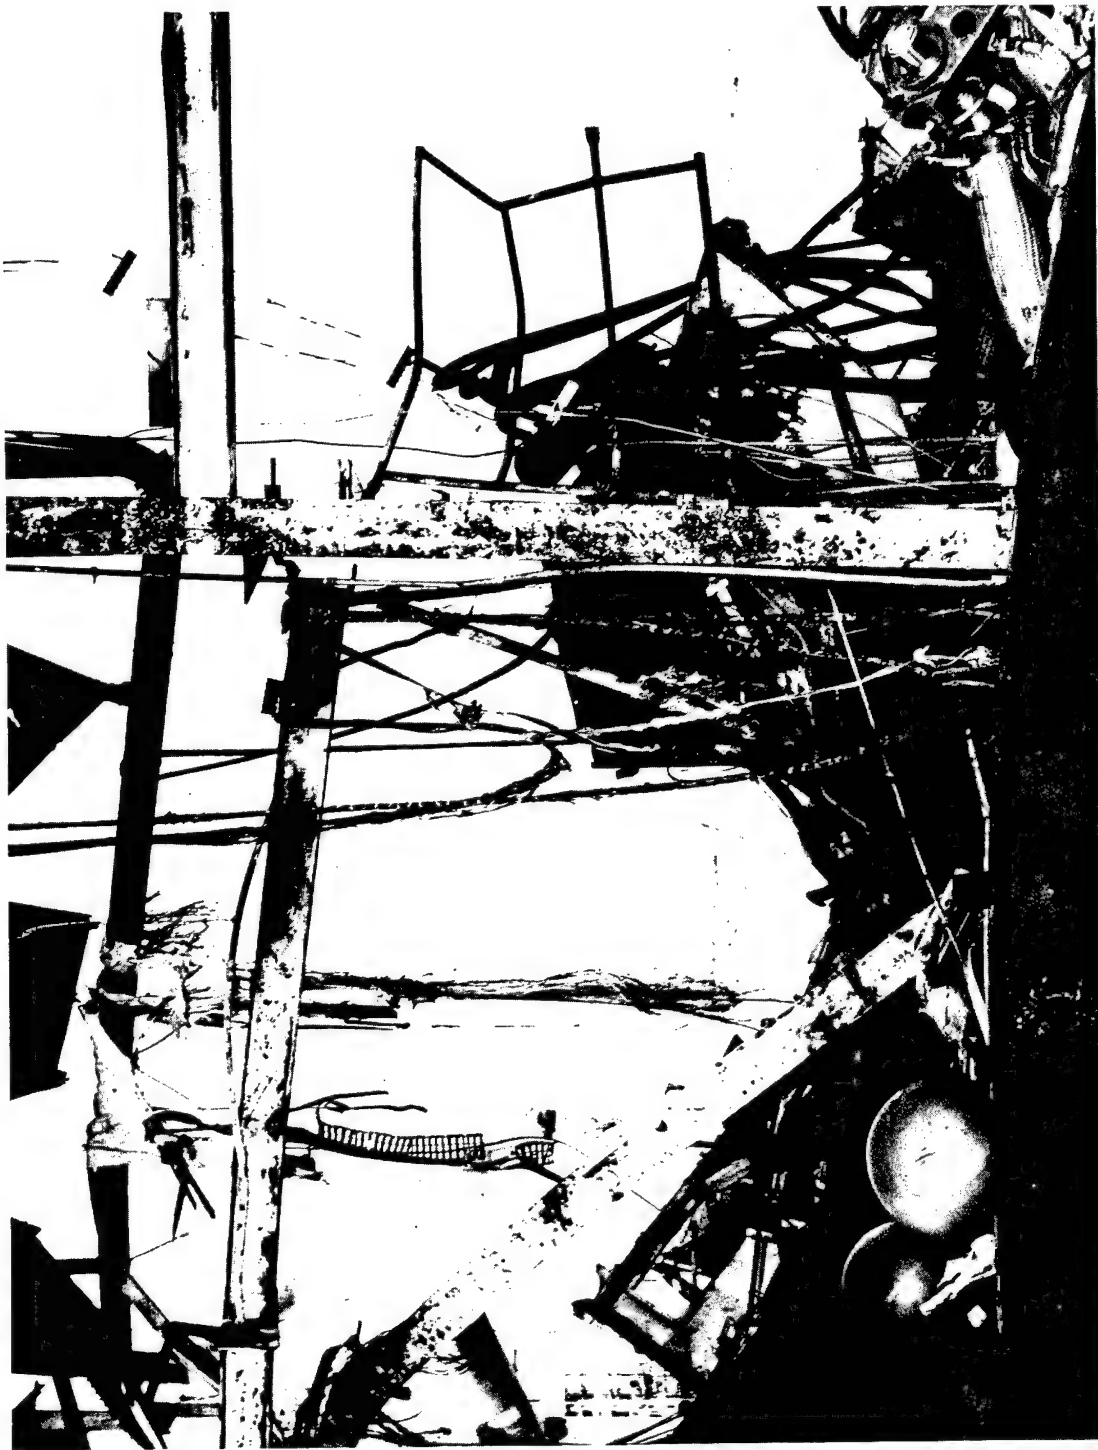
FIGURE 8. BENT STRUCTURAL MEMBERS (5th LEVEL)

Inspection of this level suggested that the explosion centered on this level, probably a few feet above the deck and near the west side of the vehicle. There was a considerable amount of structural damage above the deck. Safety railings were torn-off and thrown away. Horizontal wide flange I beams were bent horizontally, and some were torn loose. These beams had been located 10-20 feet above the deck, and deformations ranged up to about 2 feet in a 20-foot length (FIG 8).

Vertical columns were also deformed, although to a much lesser extent because they were of heavier section.

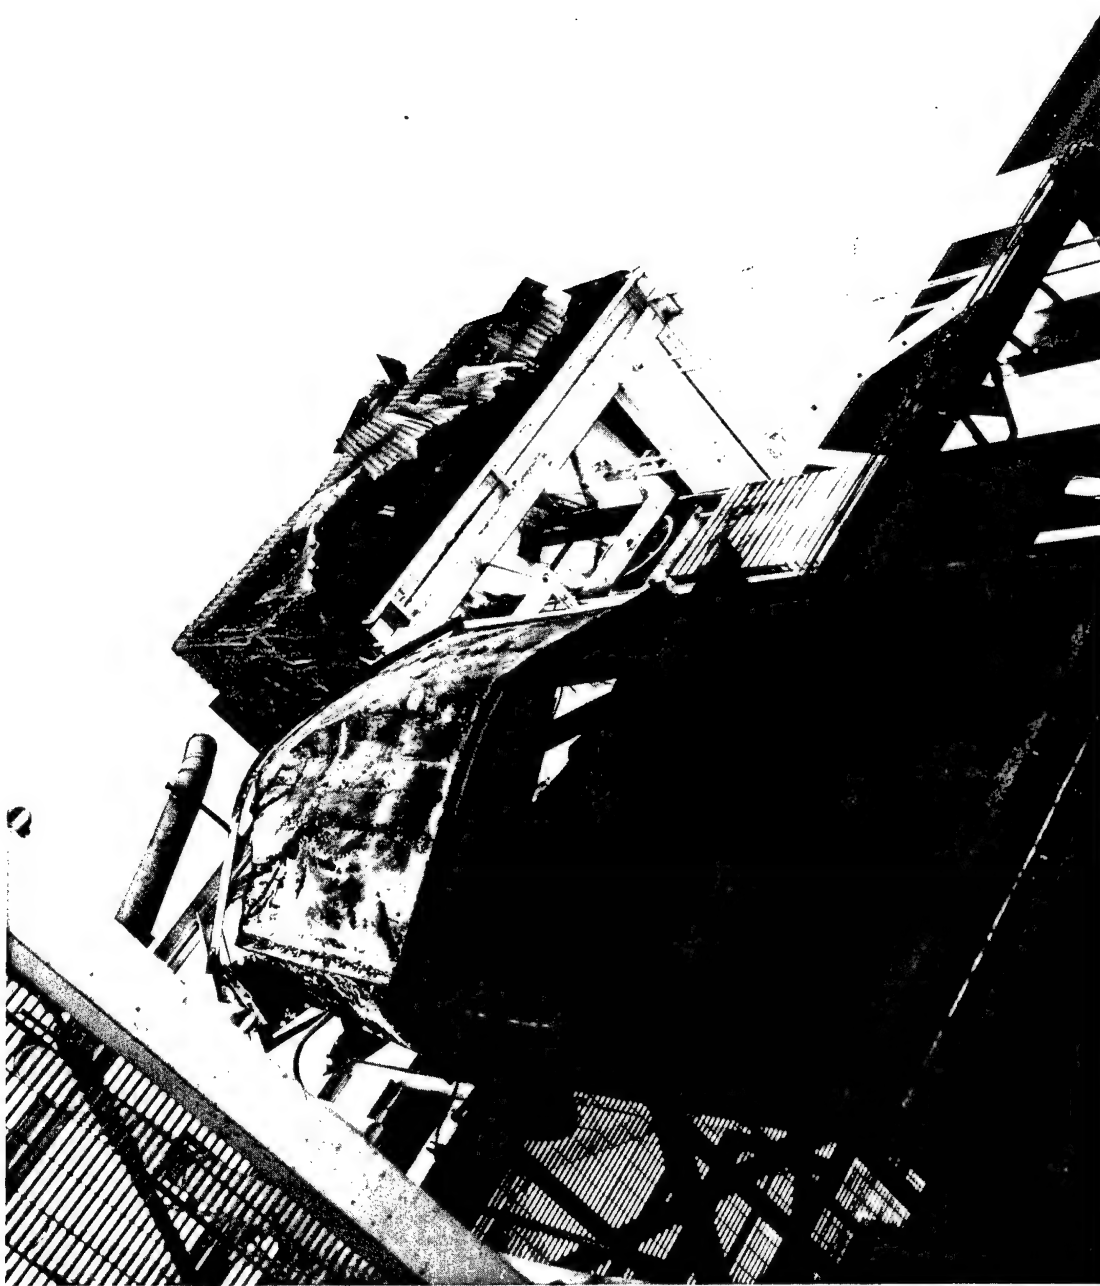
FIGURE 9. CABLE RACEWAY AND ELEVATOR SHED (6th AND 7th LEVEL)

The shed on top of the elevator, which was covered with corrugated sheet iron, had suffered some blast damage; the sheet metal was bent and was rolled-up or torn loose in places. The vertical cable duct was deformed and blown open (FIG 9).

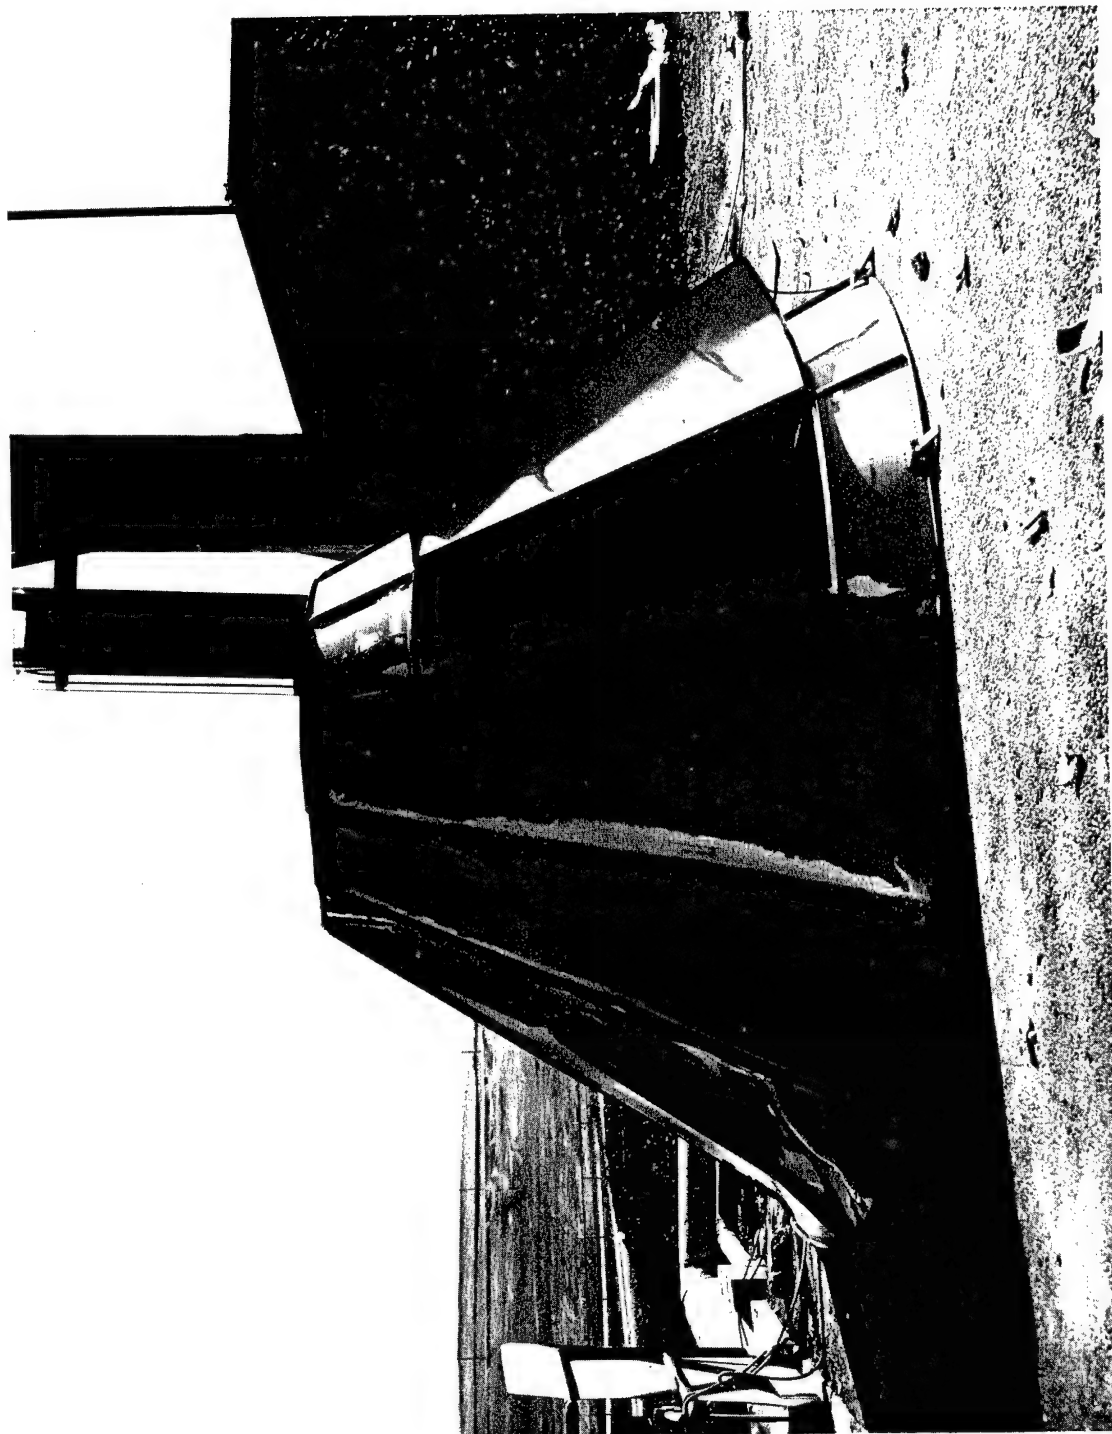
FIGURE 10. COVER PROTECTIVE ASSEMBLY

The Cover Protective Assembly was a truncated conelike structure (FIG 10) fabricated from aluminum, estimated to be approximately 1/16 inch thick. Its base diameter was 12 feet, and it tapered to a top-opening diameter of four feet. In all, there were 12 panels fastened to longitudinal stiffeners. The height of the structure was approximately six feet. The cover was positioned face down with its center 125 feet from a point on the ground beneath the explosion center. Permanent inward crushing, to a depth of six inches, was observed in several of the panels facing the blast.

The estimate of explosive weight required to produce such damage was made by using damage threshold curves similar to those given in BRL Memorandum Report 1461 but revised to include recent data. For analysis, the cover assembly was treated as a right circular cylinder with the following characteristics: length, 6 feet; diameter, 12 feet; skin thickness, 0.062 inch; material, aluminum. It was further assumed that the stiffeners increased by 10 percent the overpressure required for crushing. The analysis shows that an explosive charge of TNT weighing 1,200 pounds would be required to produce approximately the same degree of damage. The analysis also includes the assumption that the structure would have been in the Mach stem portion of the blast wave.

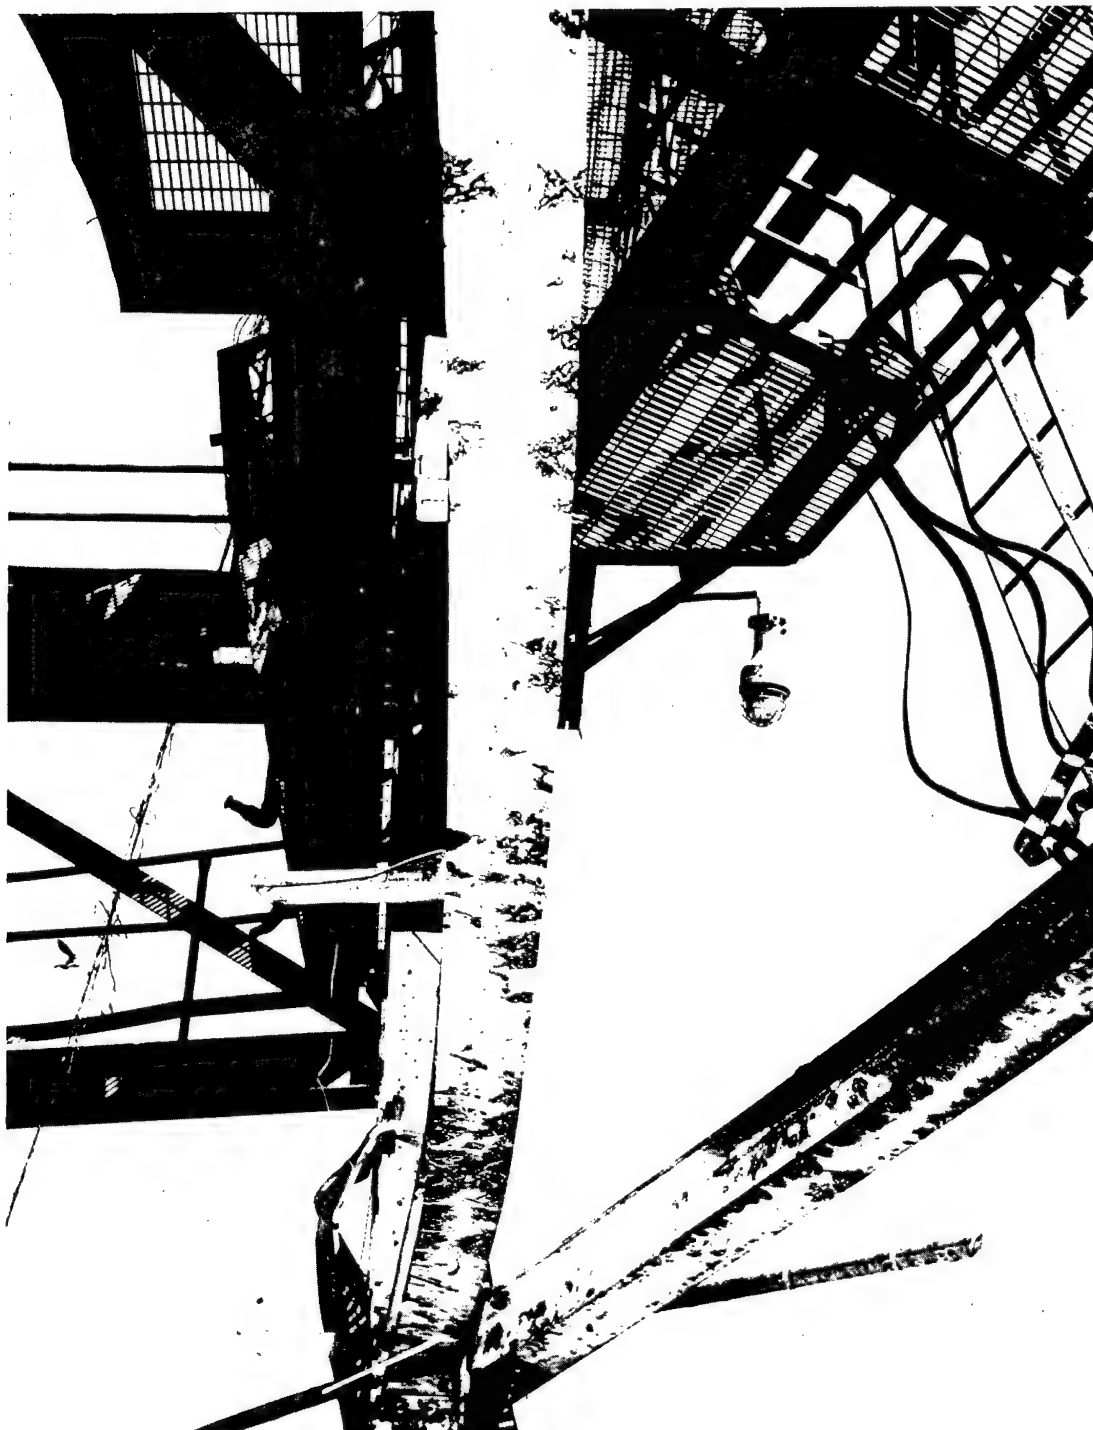
FIGURE 11. DAMAGED I-BEAM

The beam chosen for analysis (FIG 11) was the horizontal structural member (8WF 17 I-Beam, 25 feet long), located on the north side of the test stand at level 5. All the horizontal members at this level were damaged, as were some at the next higher level, 10 feet above. This beam was selected for analysis since its permanent deflection was appreciably more than allowable in the elastic range without excessive buckling. The beams on the west side were sheared from the vertical member and severely distorted and buckled. The permanent deformation of the horizontal beam on the east side was considered to be too nearly the maximum allowable elastic deflection and, to some extent, was shielded by the tank from the explosion center.

To perform the analysis, certain assumptions concerning the loading had to be made. For simplicity, the beam was considered to be simply supported and uniformly loaded. In actuality, the beam was fixed to the vertical columns and was probably not loaded uniformly since one end was several feet closer to the apparent center of explosion than the other. It was also assumed that the loading was impulsive with a positive duration approximately 1/20 the natural period of the beam. The beam was considered loaded in the strong direction; however, observations showed that some loading also occurred in the weak direction.

Based on the permanent deflection of approximately 12 inches at the center of the beam and a distance of 13 feet from the center of explosion to the beam center, it is estimated that a high explosive weight of 1,000 pounds would be required to produce such damage. This is believed to be an upper bound on the explosive weight needed to produce such a deformation based on this analysis. It is to be noted that deformation is based on the magnitude of impulse associated with 1,000 pounds of high explosive and that the characteristic pressure-time history of the fuel explosion and high explosive at this distance may be quite different
